Trail Two FOUNDRY HILL, THE FOUNDRY AND CARNSEW HILL FORT

Foundry Hill

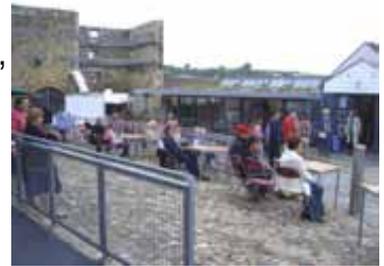
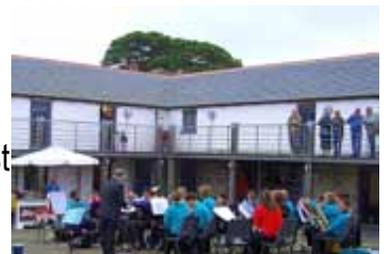
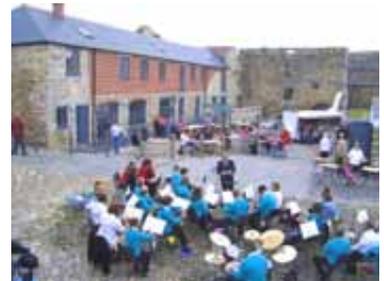
Foundry Farm: East Stables

Abutting the Foundry Barn to the east at right angles, these Grade II listed two-storey stables are of brick and stone

construction with rag-slate hipped roof. The building is a typical late 18th / early 19th century purpose-built range for the accommodation of horses, and it displays some excellent architectural detailing to the front, with arched openings. Inside, the wooden partitions, mangers, cupboards and fittings were still surviving in 2000. The block has now been extensively rebuilt using authentic materials and techniques and converted into three live-work units for local artists and craftspeople.

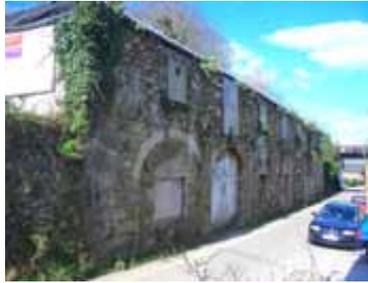
Trevithick's Stores

This Grade II listed store, also known more widely today as Plantation Stores, was part of the extension of the foundry in 1843-5, when Foundry Lane

and its large boundary walls were built. The structure is identified as a store on the plan of the Foundry of 1864. It is rectangular in plan and is built of rubble with a hipped roof that was lost in a serious fire that also destroyed most of the wagon shed (which backs on to the Pattern Shop on the opposite side of Foundry Lane). The two-storey storehouse has dressed granite quoins and a series of seven arches to the front at ground level. Of these, five are in-filled and two are open with wooden doors. The first floor window openings are irregular in size and pattern, suggesting alterations in the past. The northern end of the building has an in-filled brick arch similar to those in the roadside elevation. The truncated rear wall of the structure appears to have continued north at one stage but now has a ragged edge of unbonded masonry.

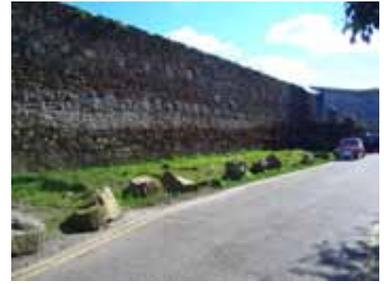
Wagon Shed

The remains of the Grade II listed wagon shed stand opposite Trevithick's Stores and back onto the Pattern Shop in the Foundry Yard below.

They shared a common pitched roof until it burned out in the fire. The wagon shed is built of rubble masonry with a curved granite wall at the southern end. The elevation facing onto Foundry Lane was open-fronted with the roof supported on octagonal wooden pillars that defined a series of structural bays where the carts were once stored. The openings onto the lane were secured by wooden doors. The rear, shared wall still shows evidence of the bearings for the wooden joists that supported the wagon shed's loft floor.

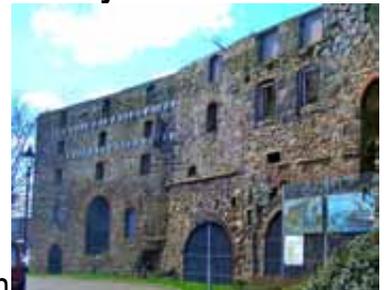
Foundry Barn: Granary

Impressive for its height and typical late 18th or early 19th century industrial design, the Grade II listed granary - also known as Foundry Barn

- is of rubble construction with dressed granite quoins and brick detailing to doors and windows. At ground level there are two arched openings that lead into vaulted chambers, whose function is unclear. The upper floors were used to store provender (oats, hay, and straw) for the foundry horse teams, and there is access from the

farmyard and stables at the rear. Line-shafts on the upper floors probably provided power for sack hoists. The structure appears from map evidence to date from circa 1825 (but possibly with an earlier core). The Trelissick estate was leased and farmed by Harvey's in the early 19th century in addition to their own small farmlands.

The building is now unroofed and internal timber floors have collapsed and been removed. As part of the initial phase of repair and conversion of the farmyard buildings, a temporary steel frame has been inserted to assure the building's stability pending its long term repair and conversion by the Harvey's Foundry Trust.

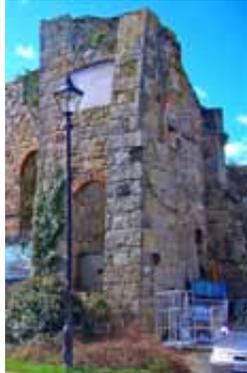
Foundry Barn: Engine and Boiler House

This Grade II listed structure forms the northern end of the building known as the Foundry Barn. Originally this was part of the Boring mill and former Erecting Shop, and should be interpreted as part of those structures rather than part of the granary to which it remains attached. The masonry structure, with its dressed granite quoins, dates from 1839-40 although there were buildings here, possibly machine erecting sheds, in 1816. There is a fine arched window to the front of the Engine House, and another arched opening at ground level giving access to the Boiler House. Inside there is good evidence of the locations of the flywheel, the supporting cross beam for the Bob and the flue of the Boiler House which led into an external stack, the base of which survives at the rear. There was a

floor above the Boiler House which may have provided office space. The power from the engine was transmitted from the engine house directly to the Boring Mill and via line-shafts to lathes, drills, and milling machines throughout the works. The engine seems to have been larger than necessary, and it is assumed to have been a showpiece for the Foundry's potential customers.

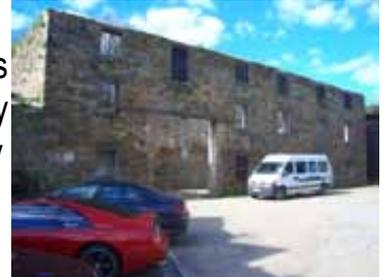
The Grade II listed Pattern Shop was built for the iron foundry in the 1840s for Harvey & Co. It is a large structure, constructed of killas and elvan

rubble masonry with granite quoins and brick detailing to some openings. The hipped roof was covered in corrugated asbestos sheets but, following arson some years ago, the building has been open to the elements. The remains of possibly earlier structures are attached at the north end next to the viaduct. The repair and reuse of this building is jointly planned by the Harvey's Foundry Trust and the harbour owners.

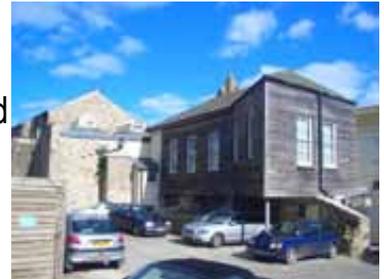
Drawing Office

Across the foundry yard to the north east and attached to the rear of John Harvey House, the former Harvey & Co's offices and showroom on Foundry Square, stands the timber framed and timber clad company drawing office supported on

columns of reused flanged iron mine-drainage pipes. Its cranked floor plan reflects the curving alignment of a mid-19th century railway track that passed under the archway of John Harvey House and linked the foundry at the centre of the yard with the company wharves on Penpol and Carnsew Quays.

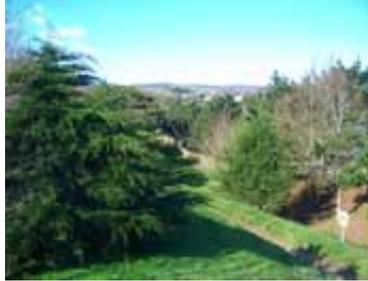
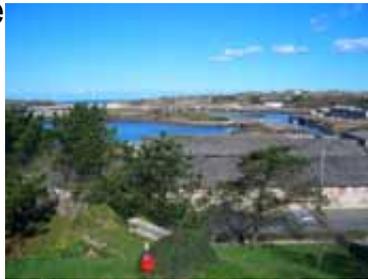
The earthwork at Carnsew appears to be a small hillfort rather than a cliff castle, with natural slopes defending the north and east sides

and with 2 ramparts, the outer surmounting the 50ft high cliff. There is an entrance in the north west with an

enclosure to the east of that and a track leading from it to the shore. The fort was probably built to command and control the estuary and a prehistoric trackway south of it. There is no sign of the earthwork having been completed by a rampart on the west side; it has probably been ploughed out. In

its present condition the original entrance cannot be identified: the entrance on the track leading from it is probably modern.

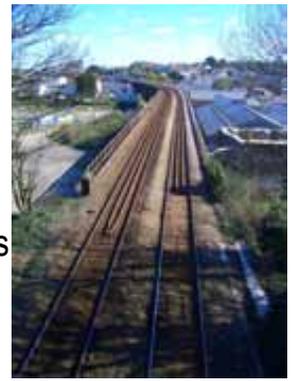
Farming and the railway cutting have removed nearly all traces of a rampart on the west side, but this may be indicated by a change in slope. The remaining ramparts were walled up and the current paths cut along them

by Henry Harvey in the construction of an ornamental park in the 1840s. He also added a series of structures and ramped walks that wind through ornamental plantations as part of a wider grandiose, classicising and landscaping activity that included an ornamental archway.

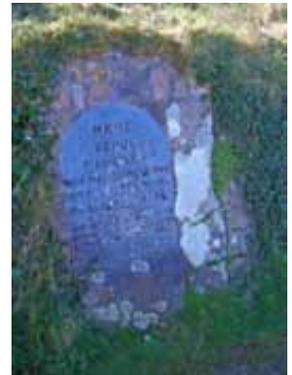
Cunaide Memorial

Close to the top of the hill fort the 4th or 5th century memorial stone built into the wall is an early relic of considerable importance.

Thought to commemorate a woman (Cunaide), or possibly her husband, the stone is the earliest known Christian

memorial in the whole of Cornwall. The actual stone, however, is not the incised slate slab, which is Victorian and a mis-translation, but the weathered granite stone to the right. Unfortunately the original inscription to Cunaide has almost completely eroded through the intervening 1500 years of weathering and lichen growth.

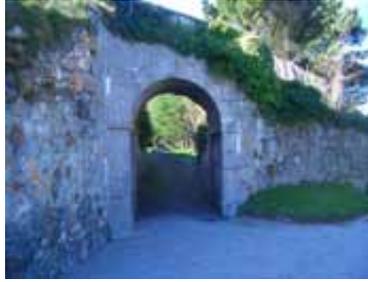
Triumphal Arch

This triumphal ornamental arch was built in 1843 of granite ashlar and straddles a pathway part way down the north east slope of the Carnsew earthwork.

The archway was built for Harvey and Company reputedly to celebrate the Leeghwater Engine contract for draining the Haarlemmer Meer in Holland. Harveys and the Copperhouse Foundry each built one of the two enormous 12 feet (3.6 m) diameter drainage pumps commissioned by the Dutch. A photograph of Harveys' first flawed cylinder casting can be found in Marlene and Martin Rews' book "Images of England – Hayle".

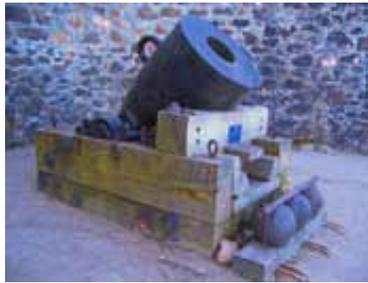
Crimean Mortar

At the foot of Henry Harvey's ramped footpath down the northern side of the hill fort stands a refurbished Crimean War mortar. Cast by Harvey & Co to an official pattern, these weapons were shipped direct to the Crimea from Hayle.

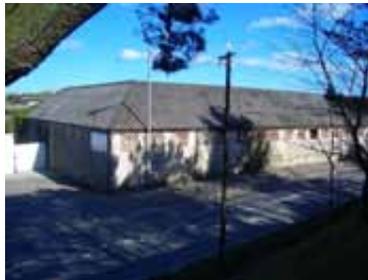
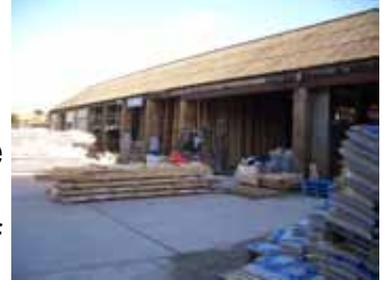
Harveys Timber Store

listed timber store is the only Harvey's building surviving north of the viaduct. The L-shaped structure is constructed of rubble containing some scoria blocks and has perforated brick ventilation panels to the roadside and west walls.

Elevations onto the timber yard are open, subdivided into bays by slender granite piers supporting the roof trusses. Several of the granite peers still have pairs of large iron pintles that once carried full height doors. Old photographs show that the roof was originally covered with Bridgwater clay tiles.

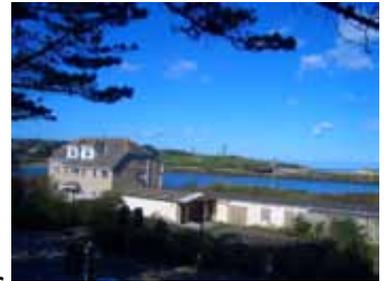
Carnsew Pool

This sluicing-water storage pool, originally known as Carnsew Basin, is perhaps the largest single surviving structure in the harbour complex. Constructed by Harveys in 1834 after the Cornish Copper Co's new quay caused silting of deep water channels to Harvey's own quays, it formed a holding pool for water to sluice out the Carnsew Channel.

Surviving with it are associated quays, sluices and lock gates and the central spit or 'New Pier' which may have had 18th century origins but was built up and extended as part of the works completed in 1834.
